Study of The Processes of Loss - Completion and Reconstruction of The Archaeological Stone Statues on The Rams Road - Luxor -

Egypt, Applying on Selected Models

Dr. Shaimaa Sayed Mohamed El-Sayed

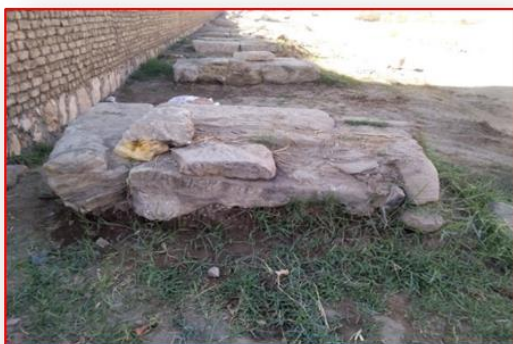
Fig (4). Shows the condition of some of the bases that were found and the effect of the various deterioration factors on them, only a course or two of its stones remain, and a great loss has occurred in them

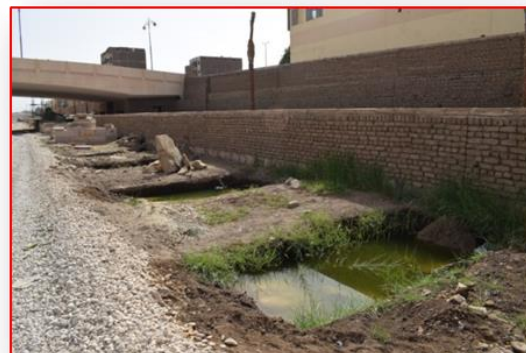
Fig (5). The presence of ground water in the site

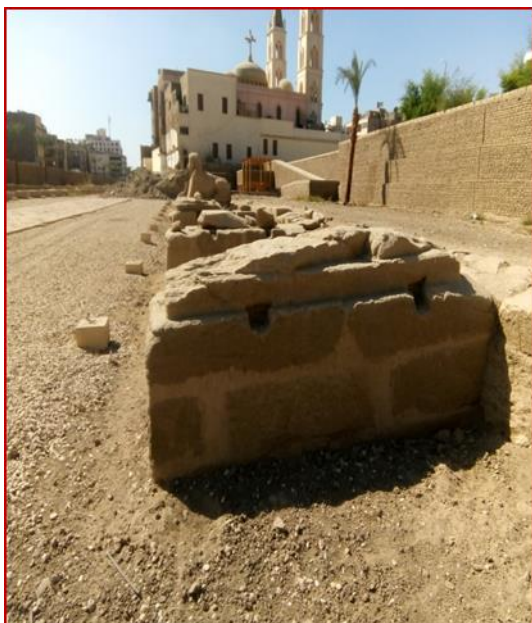
Fig (6). The loss of some statues bodies

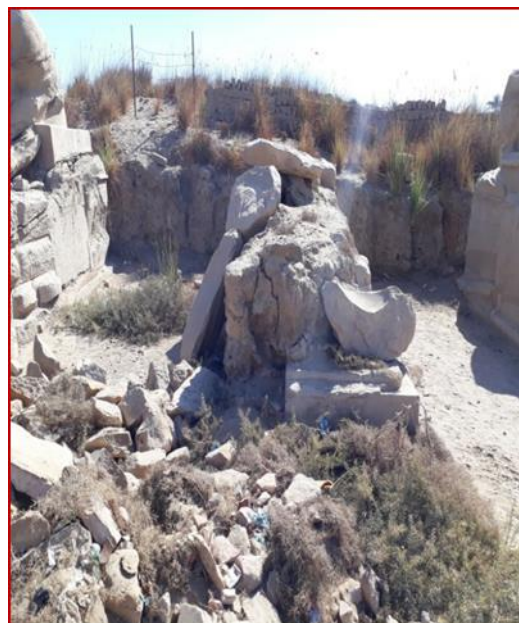
Fig (7). The condition of some of the bases of the road, which are destroyed and weeds spread, and the presence of cracks and many separations is noted

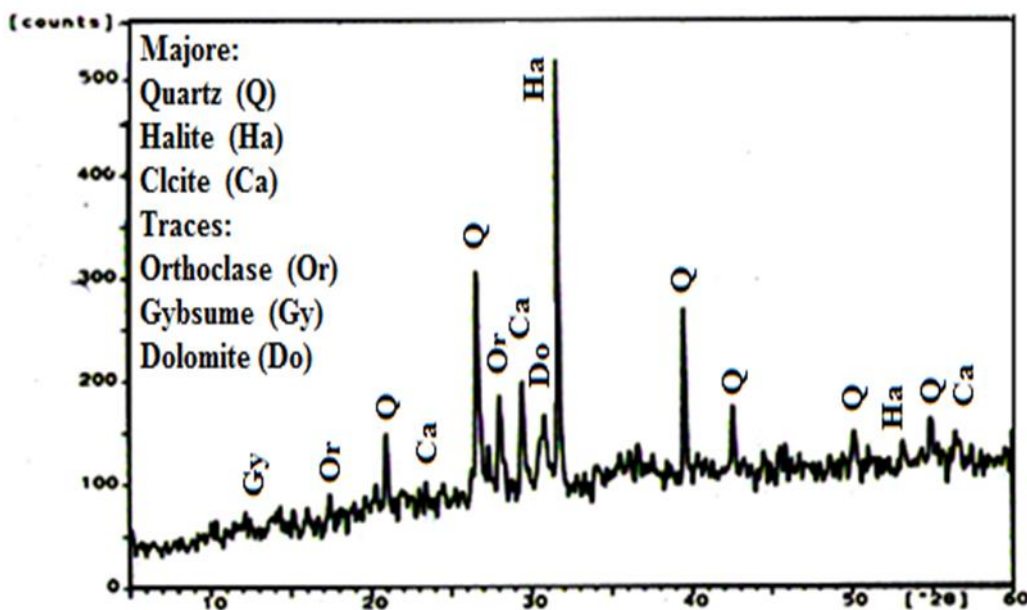
Fig (11). Analysis of a soil sample (under a statue) using X-Ray Diffraction (XRD)

The result of soil sample analysis showed that it consists of quartz, halite and calcite, in addition to orthoclase, gypsum, and dolomite, which indicates the presence of halite in a high percentage in the soil due to the ground water existence.

The soil type is a sandy soil which consists of quartz, halite and calcite, in addition to orthoclase, gypsum, and dolomite, and the presence of halite in the soil due to the groundwater effect.

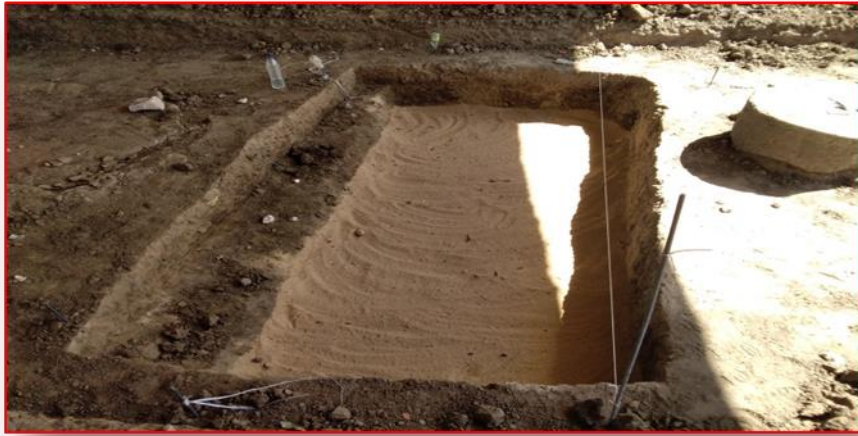
Fig (12). The shape, depth and dimensions of the hole on which the base is built and the replacement of sand and fine gravel is placed in it

- 2- A hole is made in the original base place with a depth of 50 cm and an increase in the sides of the original dimensions by 10 cm.
- 3- 20 cm of the hole is filled with gravel and sand (replacement) - Fig (12).

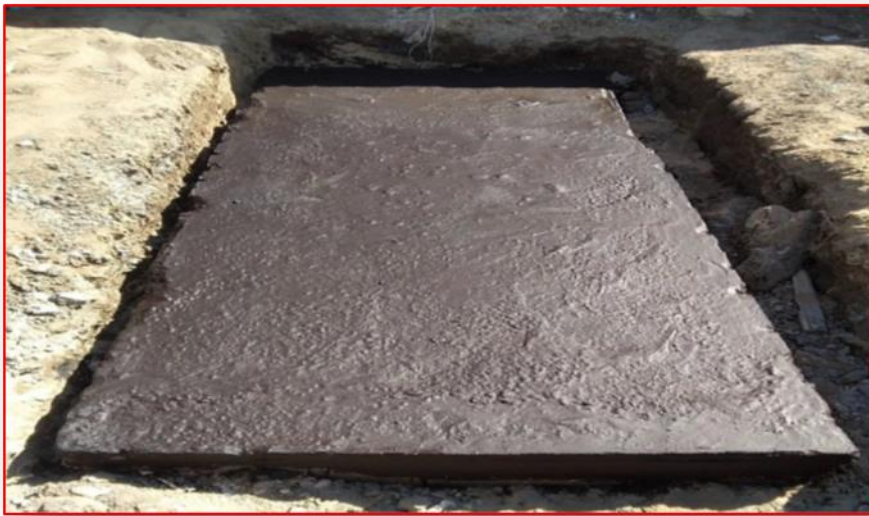
Fig (13). Shows the concrete and the dripping burlap placed on the bitumen material to protect the base from ground water

- 4- 25 cm of the hole is filled with reinforced concrete of sand, gravel and cement.
- 5- Distilled burlap is placed on concrete and bitumen is placed on it in order to isolate and protect it from ground water - Fig (13).

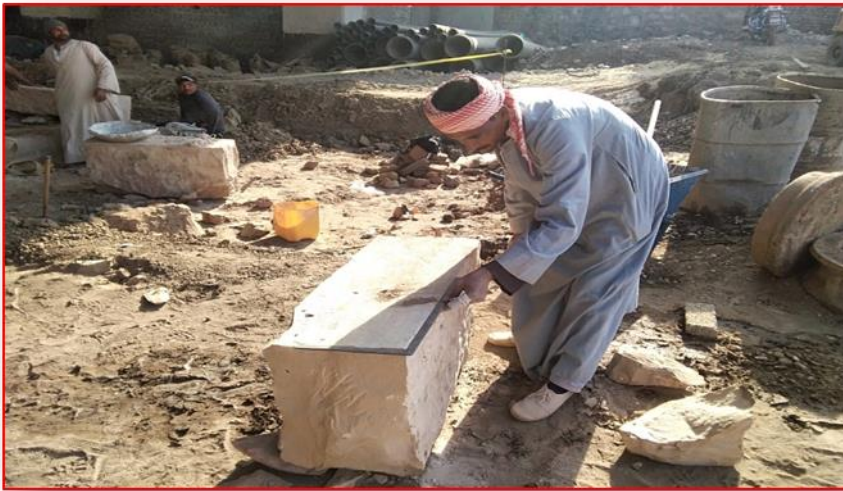
Fig (15). The work of sculptors while refining the stone blocks used in building the base (which are Nubian sandstone blocks) and determining the dimensions and sizes of each block

- 7- The foundation course, which is more than 5 cm in sides on each side, is laid, taking into account the height of its mass, according to the stone pavement facing it - Fig (15).

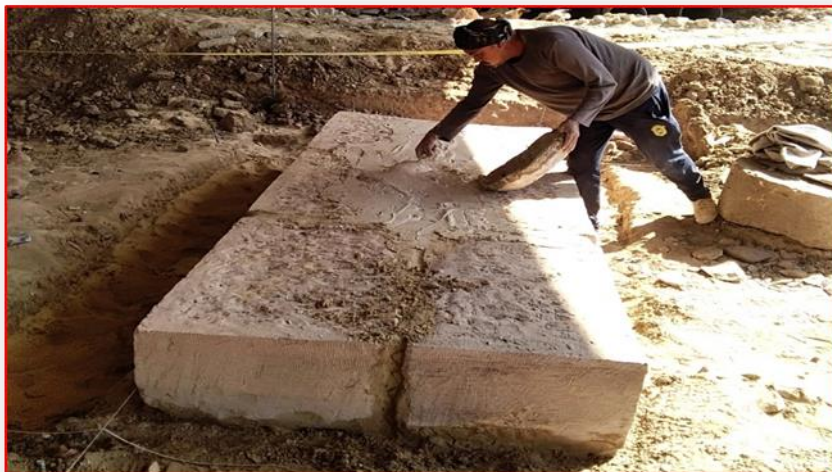
Fig (16). Placing the foundation course in the base and placing the mortar on it to connect it to the rest of the other courses

- 8- A mortar consisting of (lime + sand + white cement + stone powder + Addibond) is used and mixed with lime water in proportions (1: 3: 1: 1: 15%) - Fig (16).

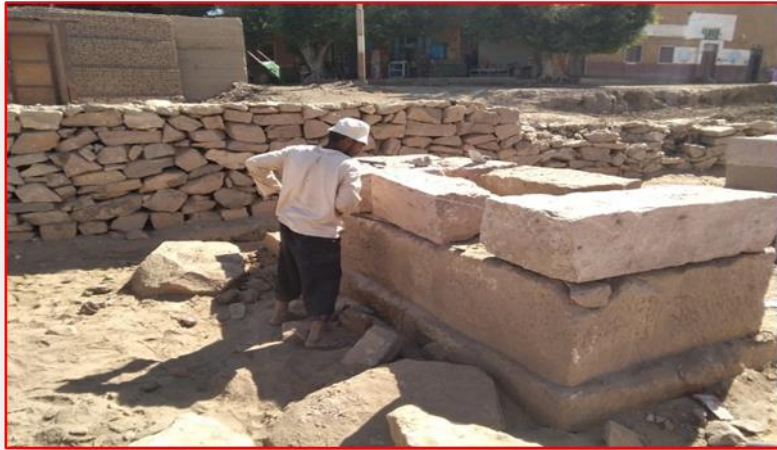
Fig (17). Shows the shape of the direction of each stone block during the construction process and its dimensions

- 9- The rest of the blocks (first, second, and third) are then completed and connected using the previous mortar, and the gaps and joints are filled with the same mortar – Fig (17- 19).

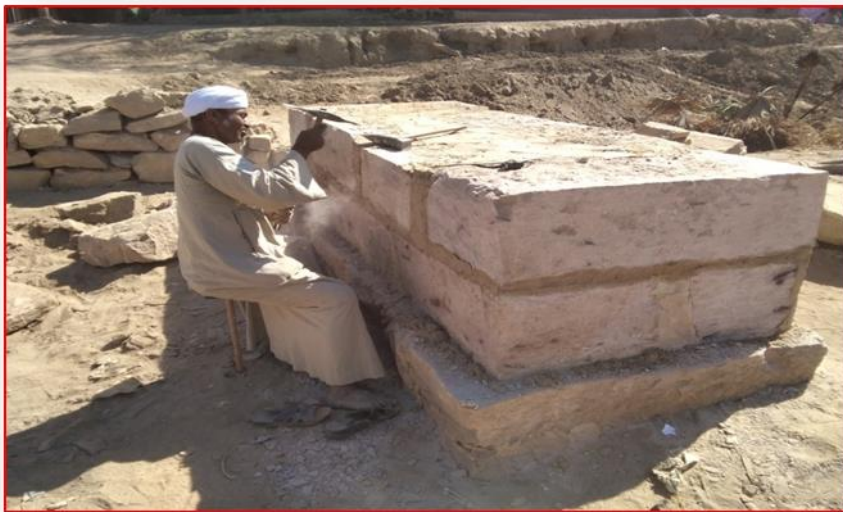
Fig (18). The shape of the first course, and the second after installation on the base and filling the gaps and joints between the stone blocks with mortar

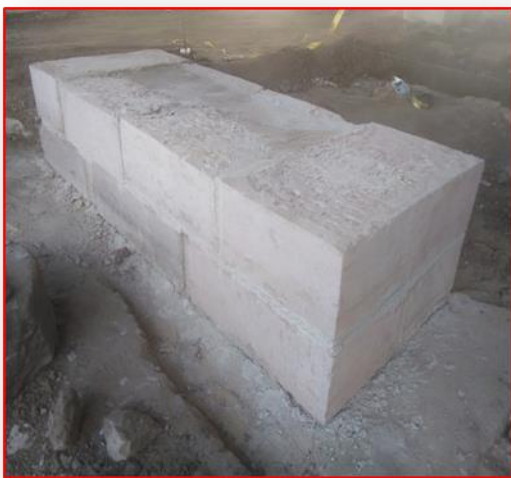
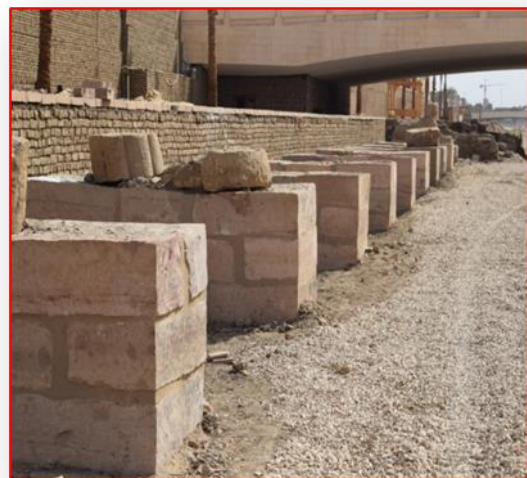
Fig (19), (A-B). Shows the shape of the base after reconstruction process, and the other figure shows some of the bases that were built in the same way in the same section of the road

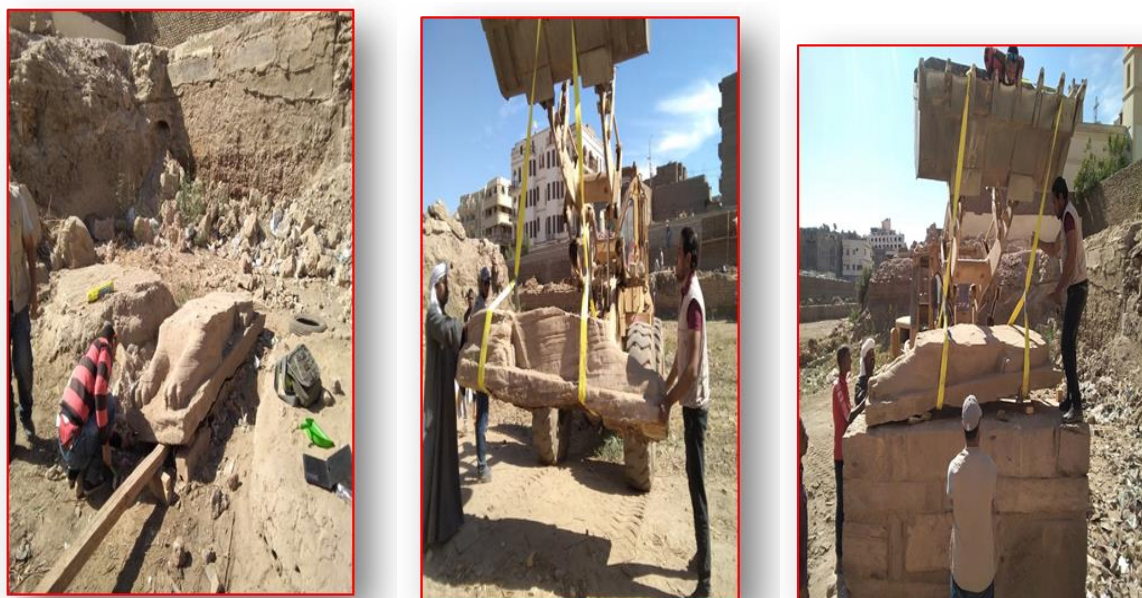
Fig (20), (A-B-C). Shows the process of raising and fixing one of the statues' bodies on the base after reconstruction process

11- The body of the statue is raised on the base after its restoration, using a silk rope so as not to scratch the body from the force of the load, since it is sandstone, and by using an appropriate lifting machine, it is installed on the base.

12- The body is fixed to the base with the same mortar used to connect the base courses to each other – Fig (20).
